# SPECIAL COUNCIL MEETING

DATE: 14 May 2026  
TIME: 10:00  
VENUE: Virtual

## **FLOOD DISASTER DAMAGE REPORT FROM 05 -11 MAY 2026**

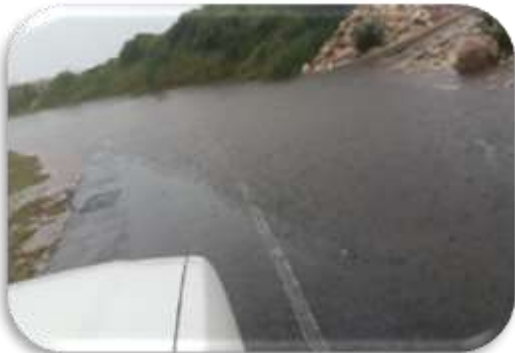
| Damage Reported in Affected Areas | Proposed Rehabilitation | Estimated Cost |
|---|---|---|
| <b>St Francis Bay</b> <ul style="list-style-type: none"> <li>Road Flooded- Peter Road</li> </ul> <p>Floodwater infiltration weakened pavement structures resulting in severe potholes, rutting, cracking, edge breaks, and unsafe driving conditions.</p> | Proposed Technical Repairs: <ul style="list-style-type: none"> <li>Milling and removal of damaged asphalt sections</li> <li>Base preparation and stabilisation</li> <li>Asphalt patching and resurfacing</li> <li>Crack sealing and edge repairs</li> <li>Road marking reinstatement where required.</li> <li>Provision for stormwater drainage.</li> </ul> | <b>R 1 150 000.00</b> |

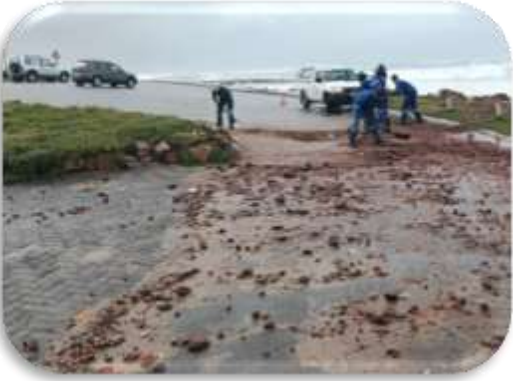
| <p><b>St Francis Bay</b></p> <ul style="list-style-type: none"> <li>• Ocean wash-off- Ann Avenue</li> </ul> <p>Description of Damage: Floodwater infiltration weakened pavement structures resulting in severe potholes, rutting, cracking, edge breaks, and unsafe driving conditions.</p> | <ul style="list-style-type: none"> <li>• Milling and removal of damaged asphalt sections</li> <li>• Base preparation and stabilisation</li> <li>• Asphalt patching and resurfacing</li> <li>• Crack sealing and edge repairs</li> <li>• Road marking reinstatement where required</li> </ul> | <b>R 850 000.00</b> |

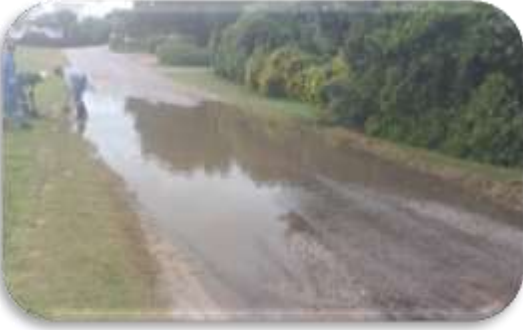
| <p><b>St Francis Bay</b></p> <ul style="list-style-type: none"> <li>• Road Flooded- Liege Road</li> </ul> <p>Flood conditions weakened road shoulders resulting in edge breaks, settlement, and unsafe roadway conditions for motorists.</p> | <p>Proposed Technical Repairs (Possible interventions once water subsided):</p> <ul style="list-style-type: none"> <li>• Milling and removal of damaged asphalt sections</li> <li>• Base preparation and stabilisation</li> <li>• Asphalt patching and resurfacing</li> <li>• Crack sealing and edge repairs</li> <li>• Road marking reinstatement where required.</li> <li>• Provision for stormwater drainage</li> </ul> | <b>R 1 150 000.00</b> |

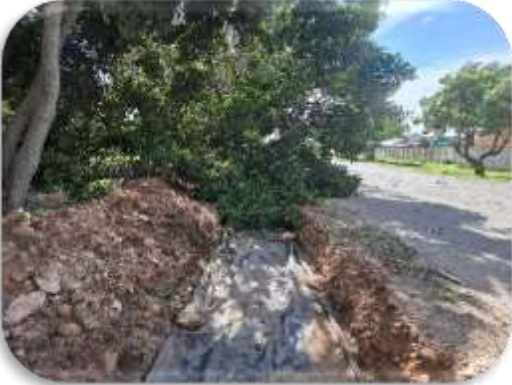
| <p><b>Jeffreys Bay</b></p> <ul style="list-style-type: none"> <li>MDRG funded Da Gama Road Stormwater project, site flooded.</li> </ul> | <ul style="list-style-type: none"> <li>Cleaning of flood damage, but no structural damage.</li> <li>Can be claimed through Contractor's insurance.</li> </ul> | <p><b>R 60 000.00</b></p> |

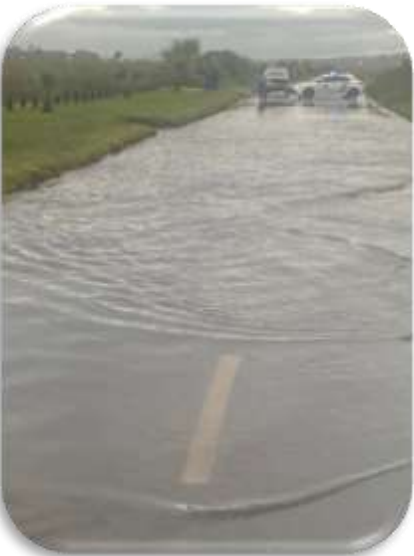
| <p><b>Aston Bay</b></p> <ul style="list-style-type: none"> <li>Road Flooded- Swan Drive</li> </ul> <p>Floodwater infiltration weakened pavement structures resulting in severe potholes, rutting, cracking, edge breaks, and unsafe driving conditions.</p> | <p>Proposed Technical Repairs (Possible interventions once water subsided):</p> <ul style="list-style-type: none"> <li>Milling and removal of damaged asphalt sections</li> <li>Base preparation and stabilisation</li> <li>Asphalt patching and resurfacing</li> <li>Crack sealing and edge repairs</li> <li>Road marking reinstatement where required.</li> </ul> | <p><b>R 850 000.00</b></p> |

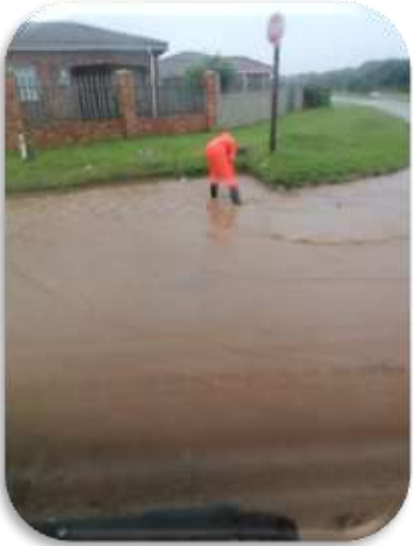
| <p><b>Jefferys Bay</b></p> <ul style="list-style-type: none"> <li>Road Flooded- Haring Street.</li> </ul> <p>High flood velocities caused culvert</p> <p>displacement, scour around structures, undermining of foundations, and structural instability at low water crossings.</p> | <p>Proposed Technical Repairs (Possible interventions once water subsided):</p> <ul style="list-style-type: none"> <li>Reconstruction and realignment of culverts</li> <li>Installation of headwalls and wingwalls</li> <li>Scour protection using gabions and rock pitching.</li> <li>Foundation stabilisation and backfilling</li> <li>Reinforcement of low water crossings</li> </ul> | <p><b>R 5 000 000.00</b></p> |

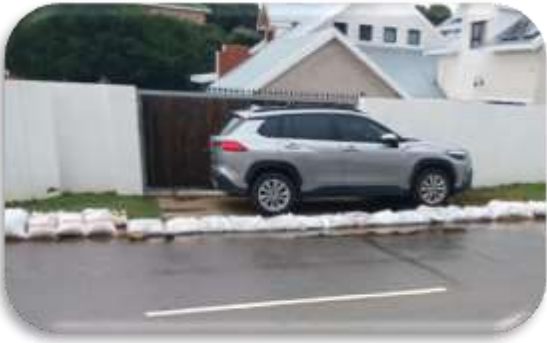
| <p><b>Jefferys Bay</b></p> <ul style="list-style-type: none"> <li>Stormwater run-off into residential ERF (sandbags preventative Measure)- Mimosa Street</li> </ul> <p>Preventative measures taken in Mimosa Street by using sandbags to prevent flooding into properties.</p> | <ul style="list-style-type: none"> <li>Increase stormwater pipe size capacity.</li> <li>Raise kerb and channel.</li> </ul> | <p><b>R 1 000 000.00</b></p> |

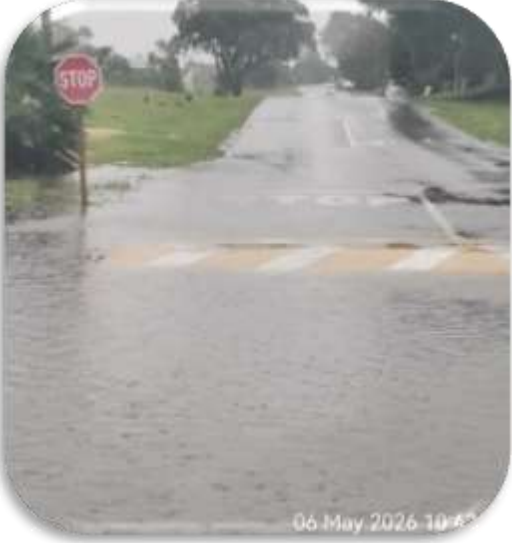
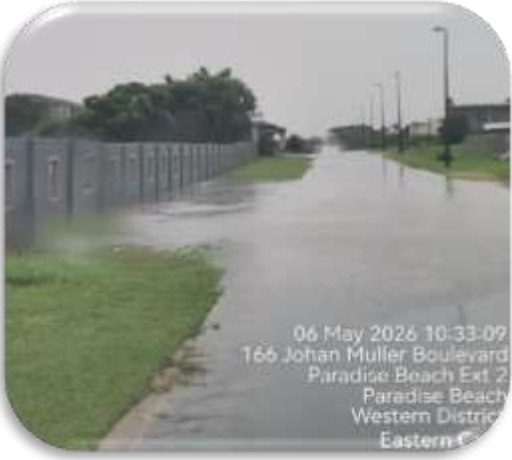
| <p><b>Paradise Beach</b></p> <ul style="list-style-type: none"> <li>Road Flooded- Johan Muller</li> </ul> <p>Flooding and excessive water saturation caused slope failures, embankment collapses, and soil instability adjacent to road reserves.</p> <p>06 May 2026 10:46</p> <p>06 May 2026 10:33:09<br/> 166 Johan Muller Boulevard<br/> Paradise Beach Ext 2<br/> Paradise Beach<br/> Western District<br/> Eastern Cape</p> | <p>Proposed Technical Repairs<br/> (Possible interventions once water subsided):</p> <ul style="list-style-type: none"> <li>Provision or Construction of stormwater drainage system and retaining structures where required.</li> <li>Subsoil drainage installation</li> <li>Vegetation rehabilitation and hydroseeding</li> </ul> | <p><b>R 3 500 000.00</b></p> |

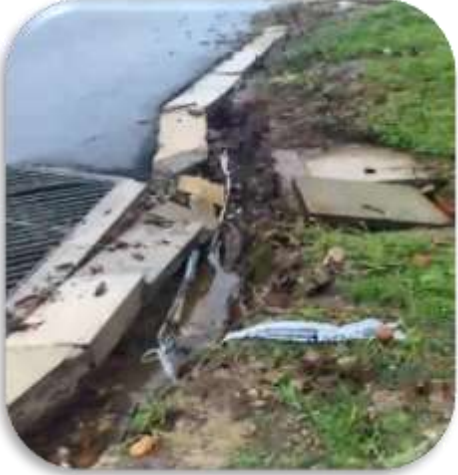
| <p><b>Jefferys Bay</b></p> <ul style="list-style-type: none"> <li>Damaged Infrastructure- Mimosa Street: Flood conditions weakened road shoulders resulting in edge breaks, settlement, and unsafe roadway conditions for motorists.</li> </ul> | <p>Proposed Technical Repairs:</p> <ul style="list-style-type: none"> <li>Reconstruction of road shoulders</li> <li>Edge reinstatement and stabilisation</li> <li>Compaction and widening where required.</li> <li>Installation of edge protection measures, kerb and channel installation.</li> </ul> | <p><b>R 1 500 000.00</b></p> |

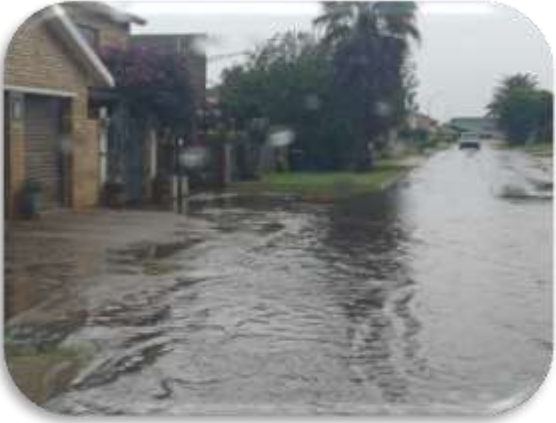
| <p><b>Jefferys Bay</b></p> <ul style="list-style-type: none"> <li>Flooded Roads and Stormwater runoff in residential ERF- Melkhout Street: Flood conditions weakened road shoulders resulting in edge breaks, settlement, and unsafe roadway conditions for motorists.</li> </ul> | <p>Proposed Technical Repairs (Possible interventions once water subsided):</p> <ul style="list-style-type: none"> <li>Reconstruction of road shoulders</li> <li>Edge reinstatement and stabilisation</li> <li>Compaction and widening where required.</li> <li>Installation of edge protection measures, kerb and channel installation.</li> </ul> | <p><b>R 750,000.00</b></p> |

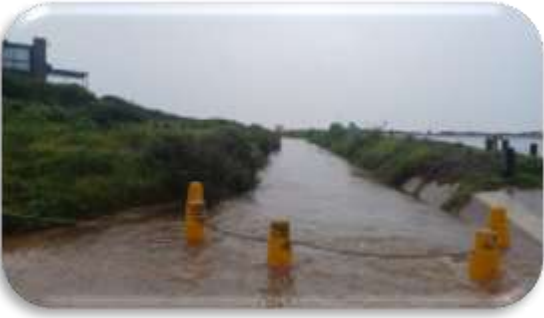
| <p><b>Jefferys Bay</b><br/>Flooded Roads and Stormwater Channel at Maximum Capacity- Kabeljous Street.</p> <p>Several drainage structures failed due to hydraulic overloading.</p> | <p>Proposed Technical Repairs:</p> <ul style="list-style-type: none"> <li>• Repair and replacement of damaged culverts, channel and pipes.</li> <li>• Reconstruction of damaged channels and catchpits</li> <li>• Upgrading undersized stormwater infrastructure where required.</li> </ul> | <p><b>R 3 800 000.00</b></p> |

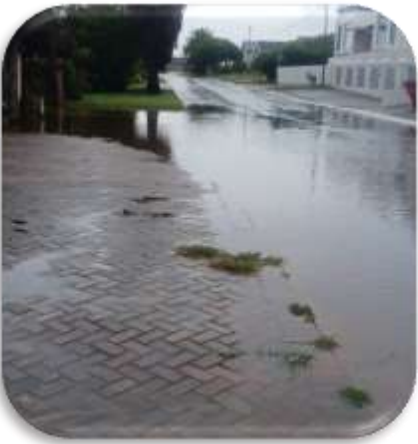
| <p><b>Jefferys Bay</b></p> <ul style="list-style-type: none"> <li>• Flooded Roads and Stormwater runoff in residential ERF- Kabeljous Street: Flood conditions weakened road shoulders resulting in edge breaks, settlement, and unsafe roadway conditions for motorists.</li> </ul> | <p>Proposed Technical Repairs (Possible interventions once water subsided):</p> <ul style="list-style-type: none"> <li>• Reconstruction of road shoulders</li> <li>• Edge reinstatement and stabilisation</li> <li>• Provision of catchpit.</li> <li>• Compaction and widening where required.</li> <li>• Installation of edge protection measures, kerb and channel installation.</li> </ul> | <p><b>R 1 250 000.00</b></p> |

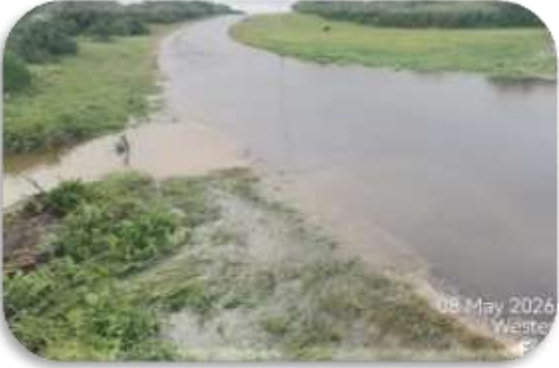
| <p><b>Aston Bay</b></p> <ul style="list-style-type: none"> <li>Flooded Road- Dolphin Drive</li> </ul> <p>Flooded Roads and Stormwater CULVERT AND LOW WATER CROSSING DAMAGE<br/> Description of Damage: High flood velocities caused culvert displacement, scour around structures, undermining foundations, and structural instability at low water crossings.</p> | <p>Proposed Technical Repairs:</p> <ul style="list-style-type: none"> <li>Reconstruction and realignment of culverts</li> <li>Installation of headwalls and wingwalls</li> <li>Scour protection using gabions and rock pitching.</li> <li>Foundation stabilisation and backfilling</li> <li>Reinforcement of low water crossings</li> </ul> | <p><b>R 5 000 000.00</b></p> |

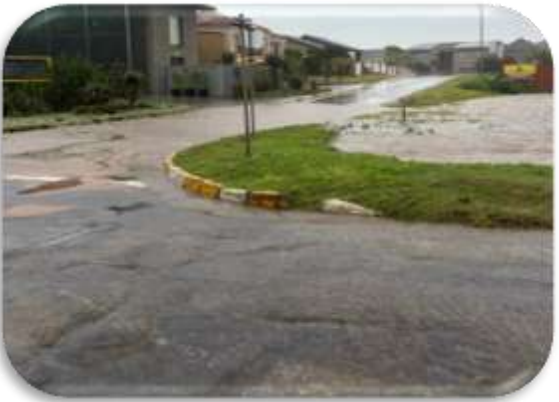
| <p><b>Jefferys Bay</b></p> <ul style="list-style-type: none"> <li>Flooded Road- Da Gama and Tecoma Street</li> </ul> <p>Stormwater systems experienced severe blockages caused by debris, silt, vegetation, and flood-related sediment deposits. Several drainage structures failed due to hydraulic overloading.</p> | <p>Proposed Technical Repairs:</p> <ul style="list-style-type: none"> <li>Repair and replacement of damaged culverts and pipes</li> <li>Reconstruction of damaged channels and catchpits</li> <li>Upgrading undersized stormwater infrastructure where required</li> </ul> | <p><b>R 2 800 000.00</b></p> |

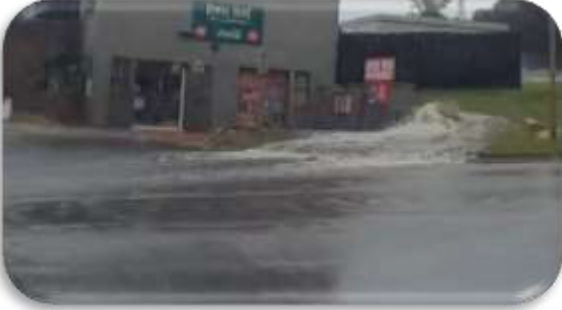
| <b>Jefferys Bay</b> <ul style="list-style-type: none"> <li>• Overflow- Noorsekloof</li> </ul> | Proposed Technical Repairs<br>(Possible interventions once<br>water subsided): <ul style="list-style-type: none"> <li>• Reconstruction of damaged channels and catchpits</li> <li>• Upgrading undersized stormwater infrastructure where required</li> </ul> | <b>R 1 800 000.00</b> |

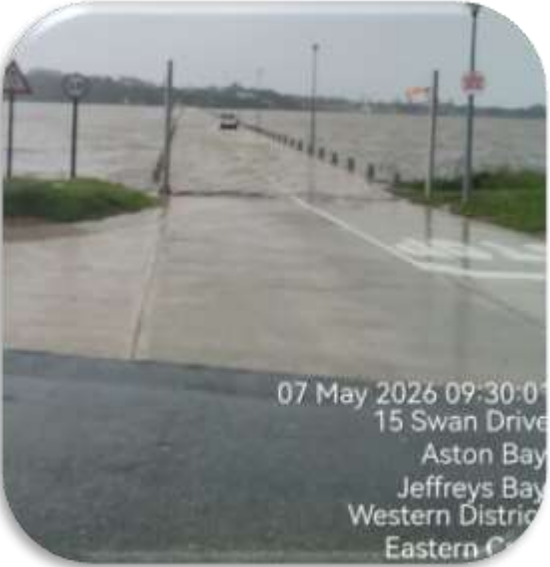
| <b>Aston Bay to Paradise Beach</b> <ul style="list-style-type: none"> <li>• Low Bridge- Causeway</li> </ul> <p>High flood velocities, scour around structures, possible undermining of foundations, and structural instability at low water crossings.</p> | Proposed Technical Repairs<br>(Possible interventions once water subsided) : <ul style="list-style-type: none"> <li>• Scour protection using gabions and rock pitching around the bridge area.</li> <li>• Foundation stabilisation and backfilling where required to.</li> <li>• Reinforcement of low water crossings.</li> <li>• Damaged of road signages.</li> </ul> | <b>R 5 000 000.00</b> |

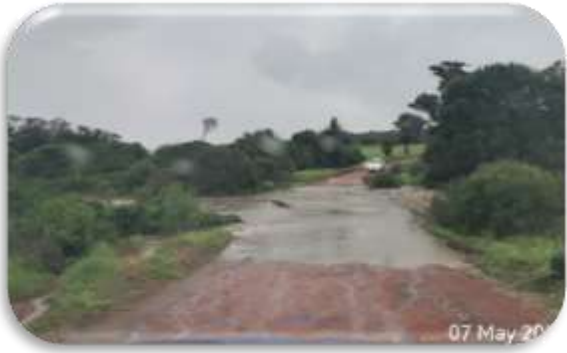
| <b>Paradise Beach</b> <ul style="list-style-type: none"> <li>• Low Bridge- Immergroen Gravel to R102 (Lombardini Lodge Road).</li> </ul> <p>Flooding, culverts undermined, and excessive water saturation caused slope failures, embankment collapses, and soil instability adjacent to road reserves.</p> | Proposed Technical Repairs<br>(Possible interventions once water subsided): <ul style="list-style-type: none"> <li>• Scour protection using gabions and rock pitching around the bridge area.</li> <li>• Foundation stabilisation and backfilling where required to.</li> </ul> | <b>R 8 000 000.00</b> |

| | <ul style="list-style-type: none"> <li>• Reinforcement of low water crossings.</li> <li>• Construction of retaining structures where required.</li> <li>• Gabion installation and erosion protection</li> <li>• Subsoil drainage installation</li> </ul> | |

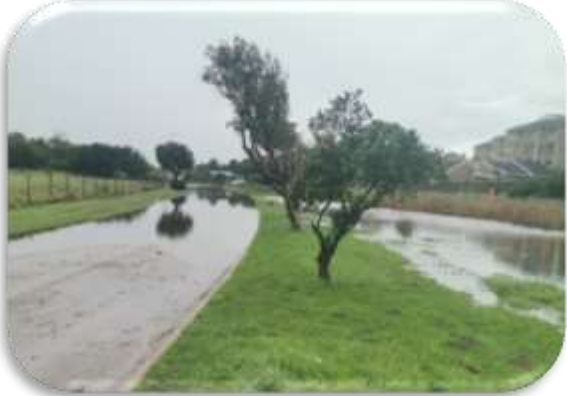
| <p><b>Aston Bay</b></p> <ul style="list-style-type: none"> <li>• Retaining Dam Full to Capacity and Overflowing and Road Flooded- Dolphin Drive</li> </ul> | <p>Proposed Technical Repairs:</p> <ul style="list-style-type: none"> <li>• Remove accumulated sediment and debris from the basin to restore the original storage capacity.</li> <li>• Increase the depth and/or footprint of the dam to accommodate higher stormwater volumes.</li> <li>• Upgrade capacity of storm pump and pipeline.</li> <li>• Undertake a detailed hydrological and hydraulic analysis to determine whether the existing infrastructure complies with current stormwater design standards and future rainfall events.</li> </ul> | <p><b>R4 500 000.00</b></p> |

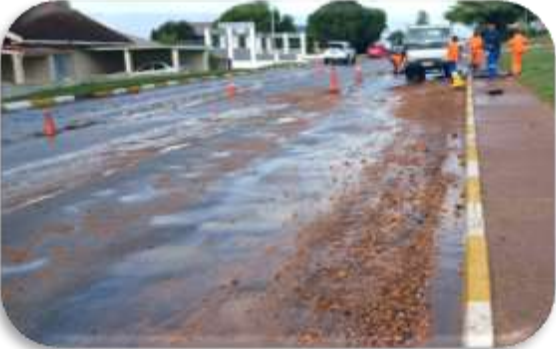
| <p><b>Jefferys Bay</b></p> <ul style="list-style-type: none"> <li>Road Damage- Da Gama Road. The road infrastructure sustained extensive damage because of heavy rainfall and excessive stormwater runoff within the area.</li> </ul> | <p>Proposed Technical Repairs (Possible interventions once water subsided):</p> <ul style="list-style-type: none"> <li>Repair potholes and failed pavement sections.</li> <li>Reinstate washed-away shoulders and embankments</li> <li>Upgrade stormwater drainage systems</li> <li>Install additional culverts or stormwater channels where required.</li> <li>Construct erosion protection measures such as gabions, riprap, or concrete-lined drains</li> </ul> | <p><b>R 3 000 000.00</b></p> |

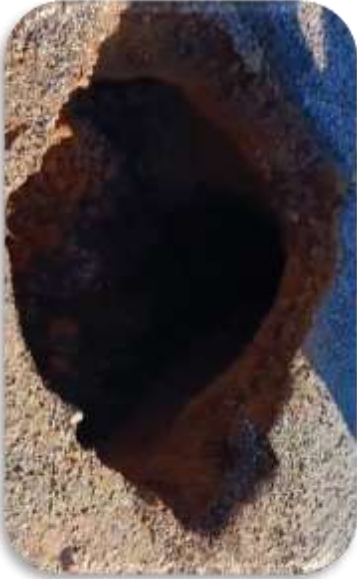
| <p><b>Jefferys Bay</b></p> <ul style="list-style-type: none"> <li>Road Damage(sinkhole)- Mopanie Street. The sinkhole developed because of prolonged and high-intensity rainfall which led to excessive stormwater infiltration and erosion of the underlying support material beneath the road surface.</li> </ul> | <p>Proposed Technical Repairs:</p> <ul style="list-style-type: none"> <li>Conduct geotechnical and stormwater investigations to determine the extent of subsurface erosion and identify the root cause of the sinkhole.</li> <li>Excavate all failed and unstable material surrounding the sinkhole until competent ground is reached.</li> <li>Repair or replace damaged stormwater pipes, culverts, manholes, or leaking services contributing to the failure.</li> <li>Backfill the excavation using approved selected fill</li> </ul> | <p><b>R 4 500 000.00</b></p> |

| | material compacted in layers to the required density specifications. | |

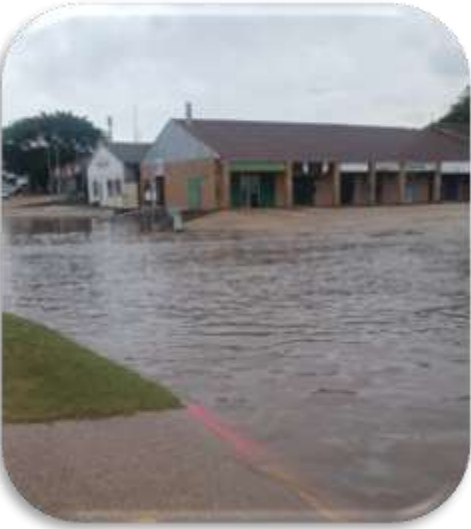
| <b>Jefferys Bay</b> <ul style="list-style-type: none"> <li>Road Flooded- St Croix Street.</li> </ul> <p>The roadway experiences flooding during rainfall events due to the insufficient capacity of the existing stormwater drainage system.</p> | <p>Proposed Technical Repairs:</p> <ul style="list-style-type: none"> <li>Undertake a detailed hydrological and hydraulic analysis to determine whether the existing infrastructure complies with current stormwater design standards and future rainfall events.</li> <li>Replace existing undersized pipes and culverts with larger-capacity stormwater infrastructure designed to accommodate the required stormwater flows.</li> <li>Construct additional catchpits, side drains, kerb inlets, and culverts to improve the collection and conveyance of stormwater runoff.</li> </ul> | <b>R 5 500 000.00</b> |

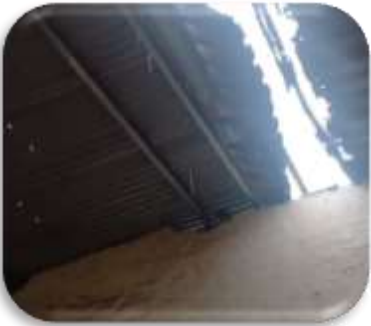
| <b>Jefferys Bay</b> <ul style="list-style-type: none"> <li>Jefferys Bay Depot roof Damage- St Croix Street.</li> </ul> <p>The roof structure sustained damage due to heavy rainfall accompanied by excessive wind conditions.</p> | <p>Proposed Technical Repairs:</p> <ul style="list-style-type: none"> <li>Conduct a detailed structural assessment to determine the extent of roof and supporting framework damage.</li> <li>Remove and replace damaged roof sheeting, tiles, flashings, ridges, fasteners, and waterproofing</li> </ul> | <b>R 450 000.00</b> |

| | <p>elements.</p> <ul style="list-style-type: none"> <li>• Repair or reinforce damaged roof trusses, purlins, rafters, and supporting members where necessary.</li> <li>• Install additional roof bracing or stronger fastening systems to improve resistance against high wind conditions.</li> </ul> | |

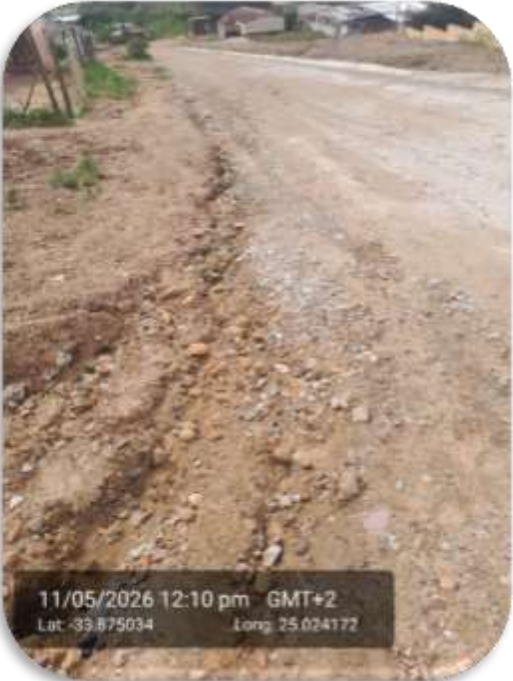
| Damage Reported in Affected Areas | Proposed Rehabilitation | Estimated Cost |
|---|---|---|
| <p><b>Loerie</b></p> <ul style="list-style-type: none"> <li>• MDRG funded Sherley Road: Wearing course washed away, primarily on road 2 and road 3</li> </ul> <p>11/05/2026 12:10 pm GMT+2<br/>Lat -33.875034 Long 25.024172</p> | <ul style="list-style-type: none"> <li>• The road surface was washed away, and the layerworks have to be re-instated.</li> <li>• Can be claimed through Contractor's insurance.</li> </ul> | <p><b>R550 000.00</b></p> |

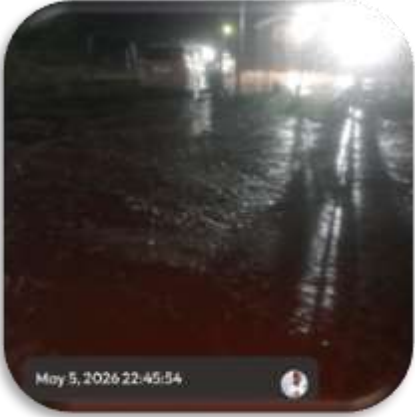
| <p><b>Gamtoos Valley:</b></p> <ul style="list-style-type: none"> <li>Stormwater run-off into residential erf- Noorshoek Street,</li> </ul> | <ul style="list-style-type: none"> <li>Milling and removal of damaged sections</li> <li>Base preparation and stabilisation</li> <li>Provision for stormwater drainage system.</li> <li>Blading of gravel road.</li> <li>Provision of drainage system and open channels</li> </ul> | <b>R 3 500 000.00</b> |

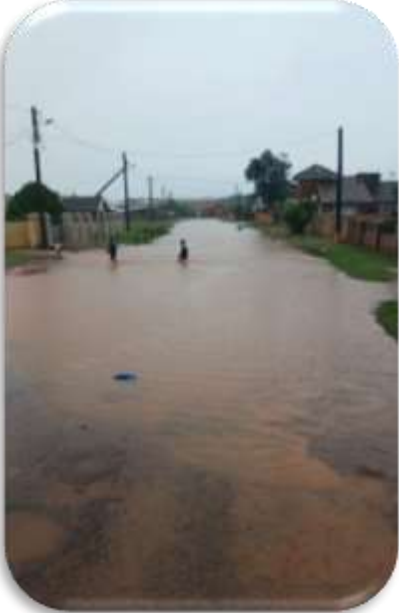
| <p><b>Hankey</b></p> <ul style="list-style-type: none"> <li>Road Flooded- Cyprus Crescent Phillipsville</li> </ul> <p>Flood conditions weakened road shoulders resulting in edge breaks, settlement, and unsafe roadway conditions for motorists.</p> | <p>Proposed Technical Repairs (Possible interventions once water subsided):</p> <ul style="list-style-type: none"> <li>Reconstruction of road shoulders</li> <li>Edge reinstatement and stabilisation</li> <li>Provision of catchpit.</li> <li>Compaction and widening where required.</li> <li>Installation of edge protection measures, kerb and channel installation.</li> </ul> | <b>R 2 500 000.00</b> |

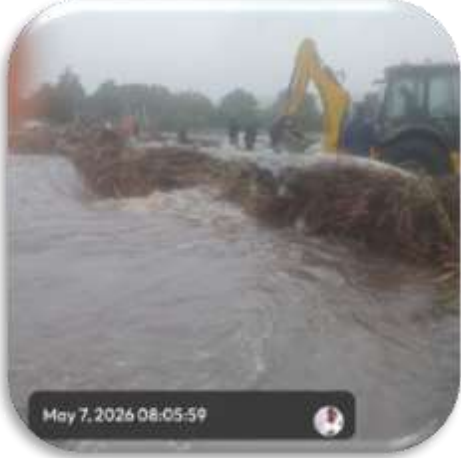
| <p><b>Hankey</b></p> <ul style="list-style-type: none"> <li>• Low Bridge- R330 to Hankey</li> </ul> <p>Flooding and excessive water saturation caused slope failures, embankment collapses, and soil instability adjacent to road reserves.</p> | <p>Proposed Technical Repairs:</p> <ul style="list-style-type: none"> <li>• Slope stabilisation, re-gravelling, and re-compaction</li> <li>• Construction of stormwater drainage system and retaining structures where required.</li> <li>• Gabion installation and erosion protection</li> <li>• Subsoil drainage installation.</li> <li>• Road blading and reshaping.</li> <li>• Importation of gravel wearing course material</li> <li>• Side drain cleaning and re-establishment</li> </ul> | <p><b>R 5 500 000.00</b></p> |

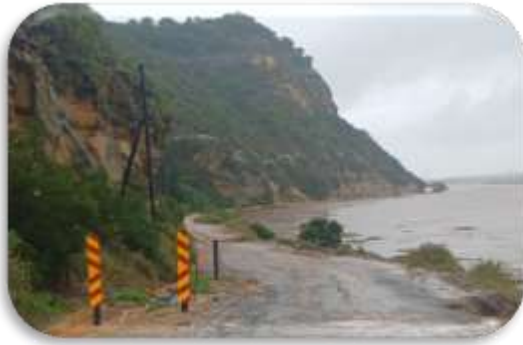
| <p><b>Gamtoos Valley:</b></p> <p>Bridge Flooded- R102 between Smithtown (Gamtoos Steel Bridge)</p> <p>Flood conditions weakened road shoulders resulting in edge breaks, settlement, and unsafe roadway conditions for motorists.</p> | <p>Proposed Technical Repairs:</p> <ul style="list-style-type: none"> <li>• Reconstruction of road shoulders</li> <li>• Edge reinstatement and stabilisation</li> <li>• Compaction and widening where required</li> <li>• Installation of edge protection measures.</li> <li>• Milling and removal of damaged asphalt sections</li> <li>• Base preparation and stabilisation</li> <li>• Asphalt patching and resurfacing</li> <li>• Crack sealing and edge repairs</li> <li>• Road marking reinstatement where required</li> </ul> | <p><b>R 8 500 000.00</b></p> |

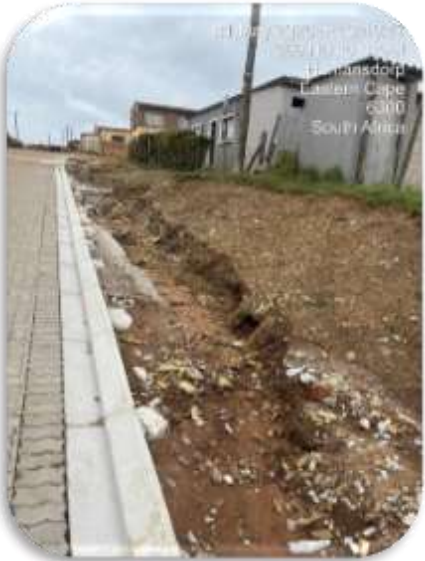
| Damage Reported in Affected Areas | Proposed Rehabilitation | Estimated Cost |
|---|---|---|
| <b>Kwanomzamo</b> <ul style="list-style-type: none"> <li>MDRG funded Nanto Street side drain washed out.</li> </ul> | <ul style="list-style-type: none"> <li>Repair damaged side drain and general clean-up.</li> <li>Can be claimed through the Contractor's insurance.</li> </ul> | <b>R300 000.00</b> |

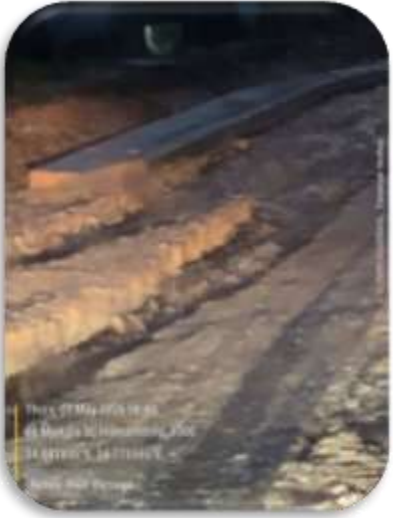
| Damage Reported in Affected Areas | Proposed Rehabilitation | Estimated Cost |
|---|---|---|
| <b>Kwanomzamo</b> <ul style="list-style-type: none"> <li>MIG funded Ketse Street portion of G6 and in-situ layer washed away.</li> </ul> | <ul style="list-style-type: none"> <li>Repair road works, including G6 and in-situ layer, as well as bellmouth that was washed away.</li> <li>Can be claimed through the Contractor's insurance.</li> </ul> | <b>R300 000.00</b> |

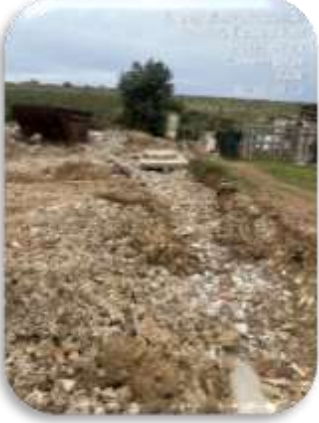
| <p><b>Kwanomzamo</b><br/> MDRG funded Ketse Street: Pipe bedding and backfill washed away. Sections of roadworks washed away.</p> | <ul style="list-style-type: none"> <li>• Re-instate pipe bedding, blanket and backfill and re-instate washed away portions of layerworks.</li> <li>• Can be claimed through the Contractor's insurance.</li> </ul> | <p><b>R300 000.00</b></p> |

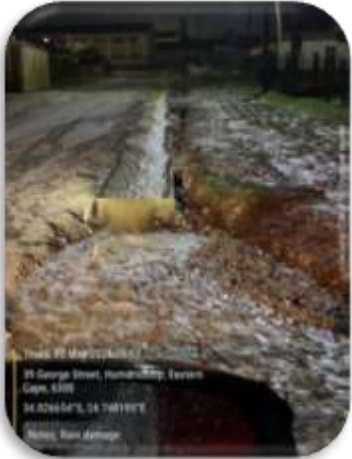
| <p><b>Arcadia:</b></p> <ul style="list-style-type: none"> <li>• MIG Funded George, Attie and Jenneker Street: General flood damage at George Road, Attie Street and Minor damage in Jenneker Street</li> </ul> <p>George Road:</p> <p>Attie Street:</p> | <ul style="list-style-type: none"> <li>• General clean-up and minor repairs at all 3 streets.</li> <li>• Can be claimed through the Contractor's insurance.</li> </ul> | <p><b>R280 000.00</b></p> |

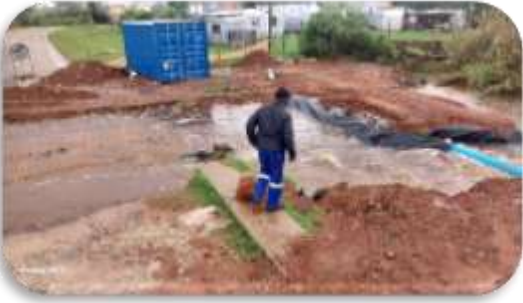
| <p><b>Kruisfontein:</b><br/>MDRG funded Phillip Street: Submerged under rainfall run-off. Berm damaged.</p> | <ul style="list-style-type: none"> <li>• Site to be cleaned out after flooding, culverts to be de-silted, re-enforcing to be cleaned, proper cleaning of concrete and construction joints.</li> <li>• Berm to be re-instated.</li> <li>• Can be claimed through the Contractor's insurance.</li> </ul> | <p><b>R250 000.00</b></p> |

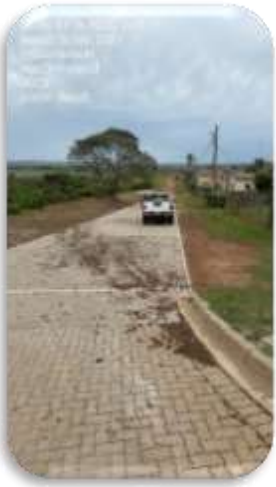
| <p><b>Kruisfontein:</b><br/>MDRG funded Meyer Street: Kerbs undermined</p> | <ul style="list-style-type: none"> <li>• Re-instate undermined kerbs.</li> <li>• Can be claimed through the Contractor's insurance.</li> </ul> | <p><b>R240 000.00</b></p> |

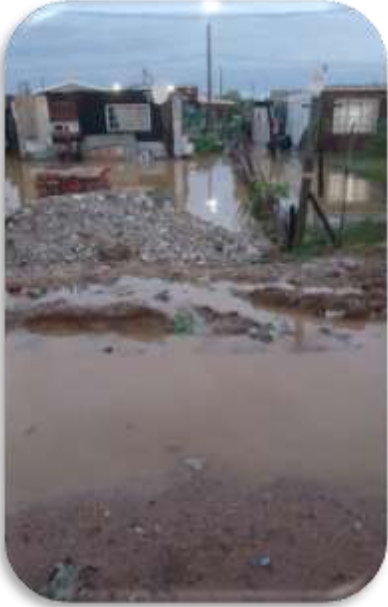
| <p><b>Kwanomzamo:</b></p> <ul style="list-style-type: none"> <li>Stormwater run-off into residential erf-Golf Course Area</li> </ul> <p>Severe rainfall and flooding resulted in the washing away of road surface material, shoulder erosion, pavement failure, and loss of structural integrity on both surfaced and gravel roads. Certain road sections became inaccessible due to extensive scour and overtopping.</p> | <p>Proposed Technical Repairs:</p> <ul style="list-style-type: none"> <li>Reinstatement of washed-away road layers</li> <li>Importation and compaction of suitable fill material</li> <li>Re-gravelling and re-sheeting of gravel roads</li> <li>Reconstruction of failed pavement layers</li> <li>Installation of erosion protection measures and side drains</li> <li>Road re-shaping and compaction using graders and rollers.</li> </ul> | <p><b>R 4 500 000.00</b></p> |

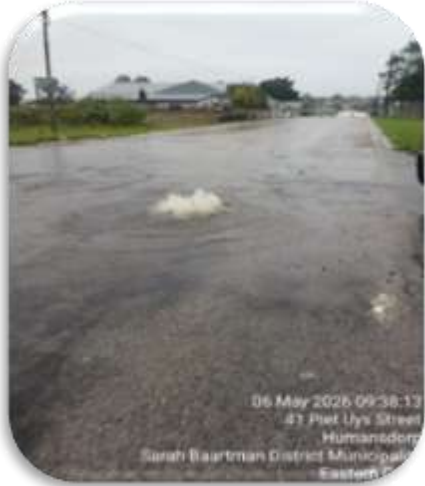
| <p><b>Kwanomzamo:</b></p> <ul style="list-style-type: none"> <li>Overflow- Park Street</li> </ul> | <p>(Possible interventions once water subsided):</p> <ul style="list-style-type: none"> <li>Milling and removal of damaged asphalt sections</li> <li>Base preparation and stabilisation</li> <li>Asphalt patching and resurfacing</li> <li>Crack sealing and edge repairs</li> <li>Road marking reinstatement where required.</li> </ul> | <p><b>R 1 500 000.00</b></p> |

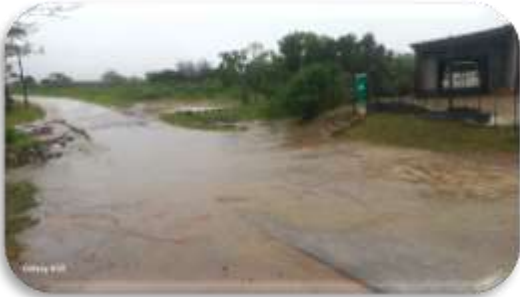
| <p><b>Kwanomzamo:</b></p> <ul style="list-style-type: none"> <li>Road Flooded- Behind Mzingisi Primary School</li> </ul> <p><b>CULVERT AND LOW WATER CROSSING DAMAGE</b></p> <p>Description of Damage: High flood velocities caused culvert displacement, scour around structures, undermining foundations, and structural instability at low water crossings.</p> | <p>Proposed Technical Repairs (Possible interventions once water subsided):</p> <ul style="list-style-type: none"> <li>Reconstruction of bridge approaches</li> <li>Embankment stabilisation</li> <li>Placement of rock armour protection</li> <li>Reinstatement of road surfacing and drainage systems</li> </ul> | <p><b>R 6 000 000.00</b></p> |

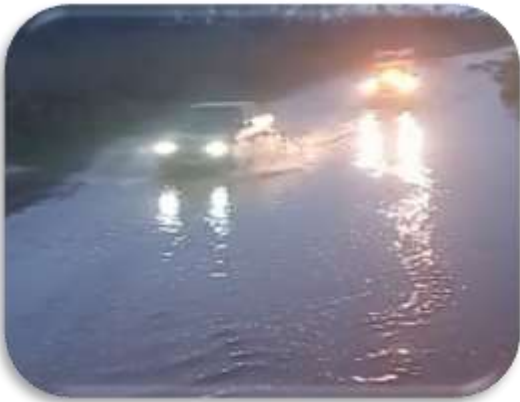
| <p><b>Kruisfontein:</b></p> <ul style="list-style-type: none"> <li>Road Flooded- Felix Street Bridge approaches experienced scour, settlement, erosion, and wash-away conditions, restricting safe access.</li> </ul> | <p>Proposed Technical Repairs(Possible interventions once water subsided) :</p> <ul style="list-style-type: none"> <li>Reconstruction of bridge approaches</li> <li>Embankment stabilisation</li> <li>Placement of rock armour protection</li> <li>Reinstatement of road surfacing and drainage systems</li> </ul> | <p><b>R 8 000 000.00</b></p> |

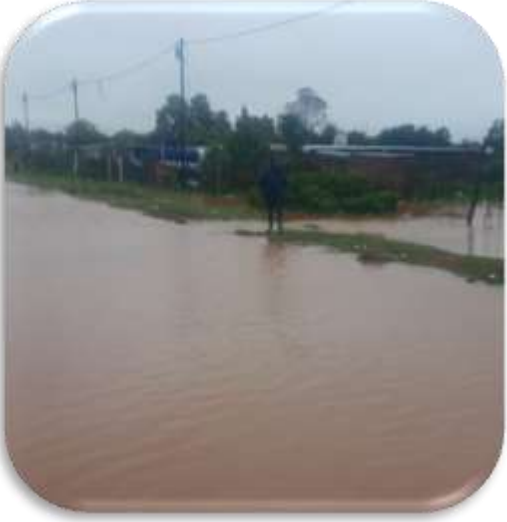
| <p><b>Kruisfontein:</b></p> <ul style="list-style-type: none"> <li>Road Flooded- 7 de Laan</li> </ul> | <p>Proposed Technical Repairs<br/>(Possible interventions once water subsided):</p> <ul style="list-style-type: none"> <li>Reinstatement of washed-away road layers</li> <li>Importation and compaction of suitable fill material</li> <li>Re-gravelling and re-sheeting of gravel roads</li> <li>Reconstruction of failed pavement layers</li> <li>Installation of erosion protection measures and side drains</li> <li>Road re-shaping and compaction using graders and rollers.</li> </ul> | <p><b>R 6 500 000.00</b></p> |

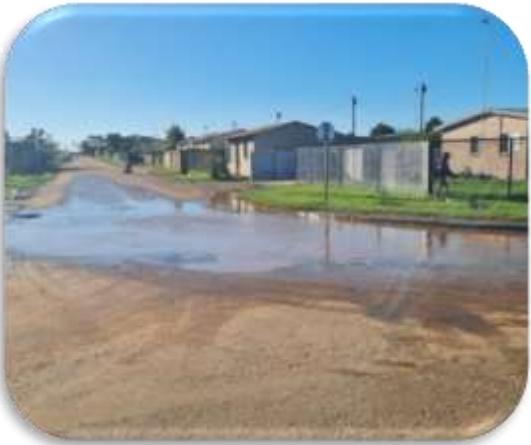
| <p><b>Maak n Las:</b></p> <ul style="list-style-type: none"> <li>Road Flooded and Ponding- Phillips Street</li> </ul> | <p>(Possible interventions once water subsided):</p> <ul style="list-style-type: none"> <li>Milling and removal of damaged asphalt sections</li> <li>Base preparation and stabilisation</li> <li>Asphalt patching and resurfacing</li> <li>Crack sealing and edge repairs</li> <li>Road marking reinstatement where required.</li> <li>Provision of stormwater drainage system.</li> </ul> | <p><b>R 3 000 000.00</b></p> |

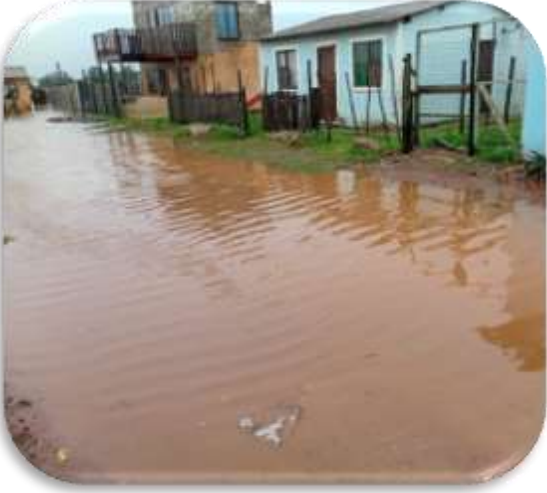
| <p><b>Maak n Las:</b></p> <ul style="list-style-type: none"> <li>Gravel Road Flooded</li> </ul> | <p>Proposed Technical Repairs<br/>(Possible interventions once water subsided):</p> <ul style="list-style-type: none"> <li>Reinstatement of washed-away road layers</li> <li>Importation and compaction of suitable fill material</li> <li>Re-gravelling and re-sheeting of gravel roads</li> <li>Reconstruction of failed pavement layers</li> <li>Installation of erosion protection measures and side drains</li> <li>Road re-shaping and compaction using graders and rollers.</li> </ul> | <p><b>R 4 500 000.00</b></p> |

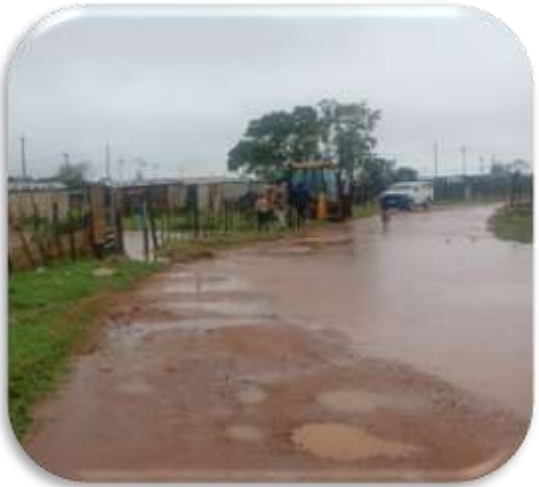
| <p><b>Maak n Las:</b></p> <ul style="list-style-type: none"> <li>Gravel Road Flooded</li> </ul> | <p>Proposed Technical Repairs:<br/>(Possible interventions once water subsided):</p> <ul style="list-style-type: none"> <li>Reinstatement of washed-away road layers</li> <li>Importation and compaction of suitable fill material</li> <li>Re-gravelling and re-sheeting of gravel roads</li> <li>Reconstruction of failed pavement layers</li> <li>Installation of erosion protection measures and side drains</li> <li>Road re-shaping and compaction using graders and rollers.</li> </ul> | <p><b>R 3 500 000.00</b></p> |

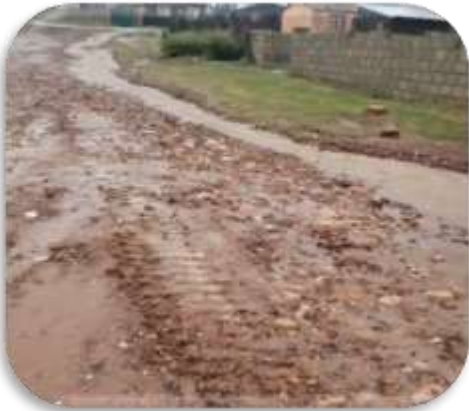
| <p><b>Maak n Las:</b></p> <ul style="list-style-type: none"> <li>Gravel Road Washed Away</li> </ul> <p>Severe rainfall and flooding resulted in the washing away of road surface material, shoulder erosion, pavement failure, and loss of structural integrity on both surfaced and gravel roads. Certain road sections became inaccessible due to extensive</p> | <p>Proposed Technical Repairs:</p> <ul style="list-style-type: none"> <li>Reinstatement of washed-away road layers</li> <li>Importation and compaction of suitable fill</li> </ul> | <p><b>R 3 500 000.00</b></p> |

| <p>scour and overtopping.</p> | <p>material</p> <ul style="list-style-type: none"> <li>• Re-gravelling and re-sheeting of gravel roads</li> <li>• Reconstruction of failed pavement layers</li> <li>• Installation of erosion protection measures and side drains</li> <li>• Road re-shaping and compaction using graders and rollers.</li> </ul> | |

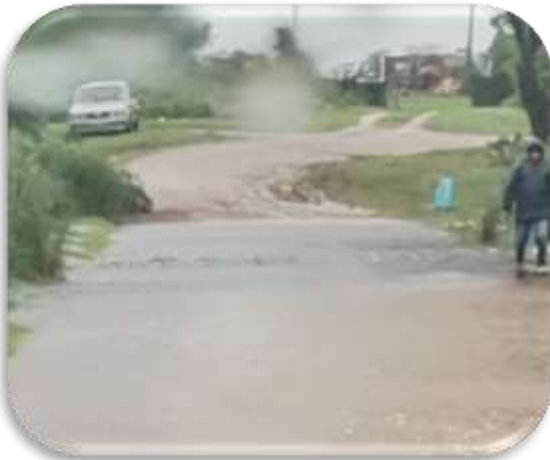
| <p><b>Kruisfontein:</b></p> <ul style="list-style-type: none"> <li>• Low Bridge- Lawerance Street</li> </ul> | <p>Proposed Technical Repairs (Possible interventions once water subsided):</p> <ul style="list-style-type: none"> <li>• Reconstruction of bridge approaches</li> <li>• Embankment stabilisation</li> <li>• Placement of rock armour protection</li> <li>• Reinstatement of road surfacing and drainage systems</li> </ul> | <p><b>R 11 500 000.00</b></p> |

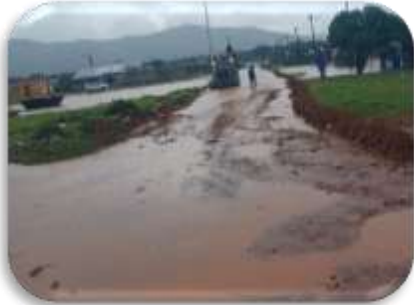
| <p><b>Kruisfontein:</b></p> <ul style="list-style-type: none"> <li>• Gravel Road Flooded- Allwyn Street</li> </ul> | <p>Proposed Technical Repairs:</p> <ul style="list-style-type: none"> <li>• Reinstatement of washed-away road layers</li> <li>• Importation and compaction of suitable fill material</li> <li>• Re-gravelling and re-sheeting of gravel roads</li> <li>• Reconstruction of failed pavement layers</li> </ul> | <p><b>R 3 500 000.00</b></p> |

| | <ul style="list-style-type: none"> <li>• Installation of erosion protection measures and side drains</li> <li>• Road re-shaping and compaction using graders and rollers.</li> </ul> | |

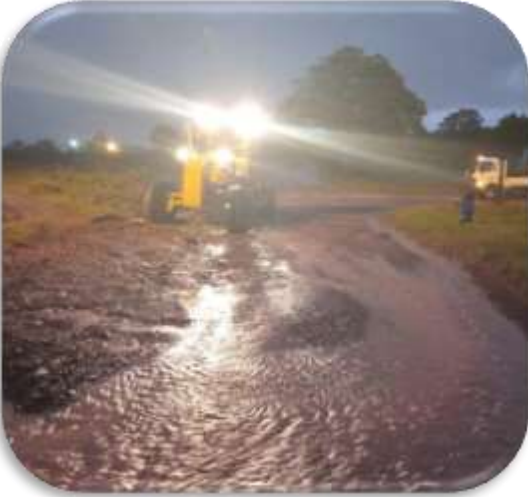
| <p><b>Mooi Uitsig:</b></p> <ul style="list-style-type: none"> <li>• Gravel Road Washed Away</li> </ul> | <p>Proposed Technical Repairs:</p> <ul style="list-style-type: none"> <li>• Reinstatement of washed-away road layers</li> <li>• Importation and compaction of suitable fill material</li> <li>• Re-gravelling and re-sheeting of gravel roads</li> <li>• Reconstruction of failed pavement layers</li> <li>• Installation of erosion protection measures and side drains</li> <li>• Road re-shaping and compaction using graders and rollers.</li> </ul> | <b>R 3 800 000.00</b> |

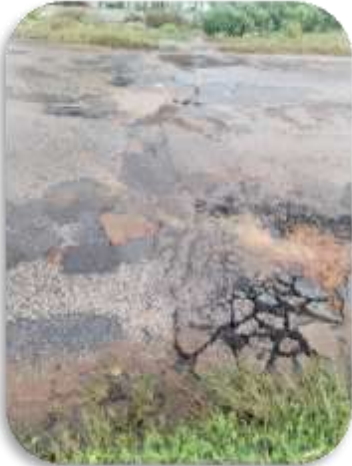
| <p><b>Kruisfontein:</b></p> <ul style="list-style-type: none"> <li>• Road Damage- Jacob Street</li> </ul> | <ul style="list-style-type: none"> <li>• Milling and removal of damaged asphalt sections</li> <li>• Base preparation and stabilisation</li> <li>• Asphalt patching and resurfacing</li> <li>• Crack sealing and edge repairs</li> <li>• Road marking reinstatement where required.</li> <li>• Provision of stormwater drainage system.</li> </ul> | <b>R 4 500 000.00</b> |

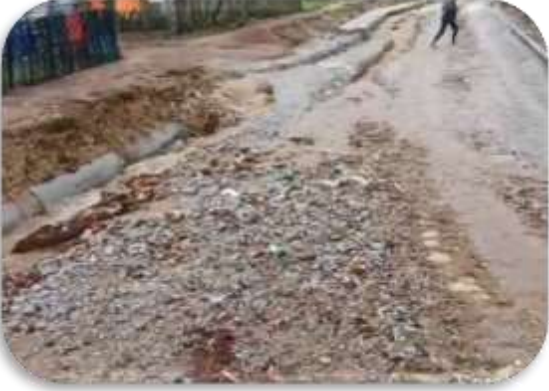
| <p><b>Kruisfontein:</b></p> <ul style="list-style-type: none"> <li>Road Washed Away- Zakhe Street</li> </ul> | <p>Proposed Technical Repairs:</p> <ul style="list-style-type: none"> <li>Reinstatement of washed-away road layers</li> <li>Importation and compaction of suitable fill material</li> <li>Re-gravelling and re-sheeting of gravel roads</li> <li>Reconstruction of failed pavement layers</li> <li>Installation of erosion protection measures and side drains</li> <li>Road re-shaping and compaction using graders and rollers</li> </ul> | <p><b>R 3 800 000.00</b></p> |

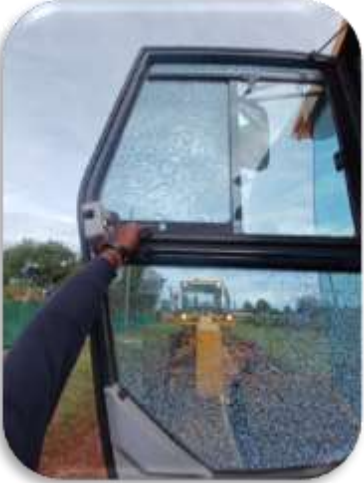
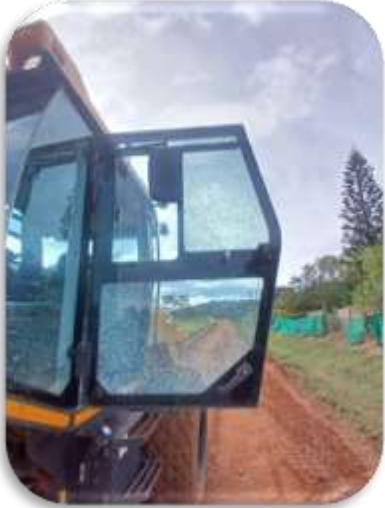
| <p><b>Kruisfontein:</b></p> <ul style="list-style-type: none"> <li>Plant Damage, Operators Attacked- Williams Street</li> </ul> <p>The roller window sustained damage because of impact from an unidentified projectile object.</p> | <p>Proposed Technical Repairs:</p> <ul style="list-style-type: none"> <li>Conduct a detailed inspection to determine the extent of structural and mechanical damage to the roller window system.</li> <li>Safely remove broken glass, damaged shutter sections, and compromised fittings.</li> <li>Ensure the repaired installation restores adequate weather protection, security, and structural stability.</li> </ul> | <p><b>R 30 000.00</b></p> |

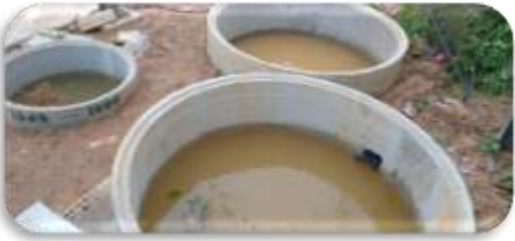
| Damage Reported in Affected Areas | Proposed Rehabilitation | Estimated Cost |
|---|---|---|
| <p><b>Loerie Sewer Pump Station</b></p> <ul style="list-style-type: none"> <li>Sump manholes flooded and trenches washed away.</li> </ul> | <ul style="list-style-type: none"> <li>Manholes to be de-sludged and trenches to be backfilled</li> <li>Can be claimed through the Contractor's insurance</li> </ul> | <p><b>R150 000.00</b></p> |

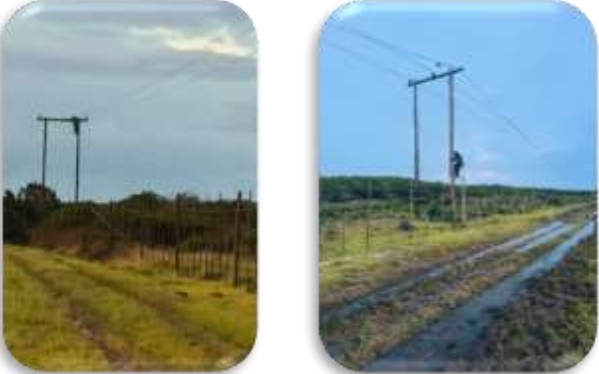
| Damage Reported in Affected Areas | Proposed Rehabilitation | Estimated Cost |
|---|---|---|
| <p><b>Jeffreys Bay</b></p> <p><b>Paradise overhead 11kV line</b></p> <ul style="list-style-type: none"> <li>MV line pole broke due to excessive rain and post insulators were broken down and affecting 8 structures.</li> </ul> | <ul style="list-style-type: none"> <li>The broken line and insulators were repaired.</li> </ul> | <b>R350 000.00</b> |

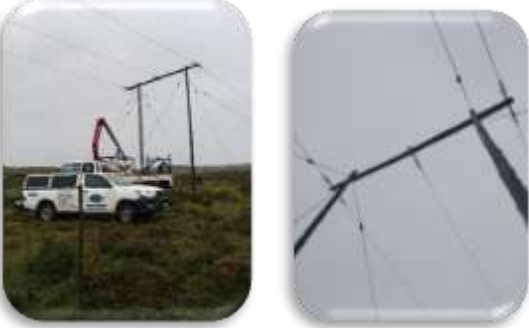
| Damage Reported in Affected Areas | Proposed Rehabilitation | Estimated Cost |
|---|---|---|
| <p><b>Paradise overhead 11kV line</b></p> <ul style="list-style-type: none"> <li>Broken line, Jumpers, and post insulators.</li> </ul> | <ul style="list-style-type: none"> <li>Following the previous fault.</li> </ul> | <b>R350 000</b> |

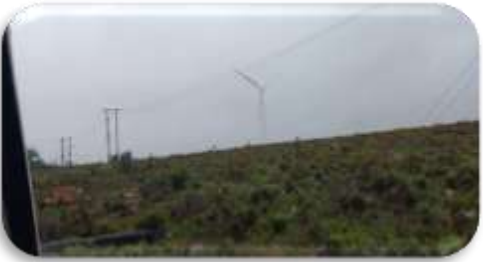
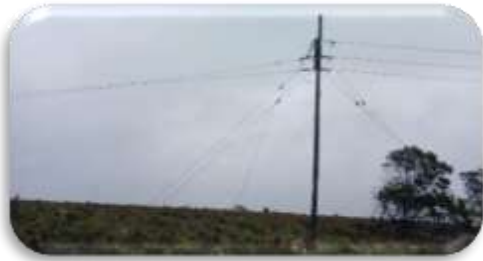
| Damage Reported in Affected Areas | Proposed Rehabilitation | Estimated Cost |
|---|---|---|
| <p><b>Farmers overhead 22kV line</b></p> <ul style="list-style-type: none"> <li>Broken conductor that affected Mark Holiday.</li> </ul> | <ul style="list-style-type: none"> <li>Replace and repair broken conductors and components.</li> </ul> | <b>R 50 000</b> |

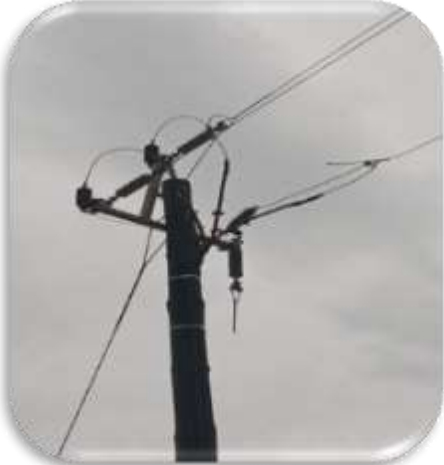
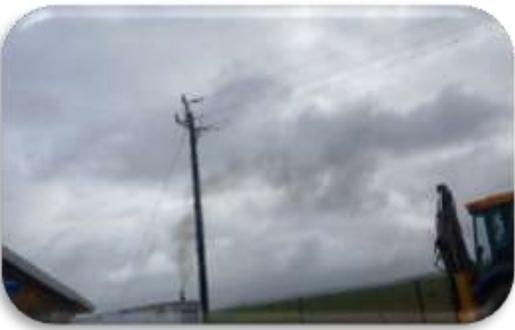
| <p>Broken conductor that affecting Jeffreys Bay Wastewater treatment plant. Ground saturated causing pole to shif.</p> | <ul style="list-style-type: none"> <li>Replace and repair broken conductors and components.</li> </ul> | <p><b>R 45 000</b></p> |

| | <ul style="list-style-type: none"> <li>Replace the pole</li> </ul> | <p><b>R50 000.00</b></p> |

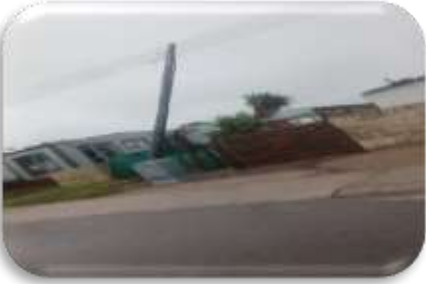
| <p><b>PELLSRUS- DOLPHINE STREET</b></p> <ul style="list-style-type: none"> <li>Broken LV pole in Dolphine Street. Ground extremely wet due to rains.</li> </ul> | <p>and string and tension the conductor.</p> | |

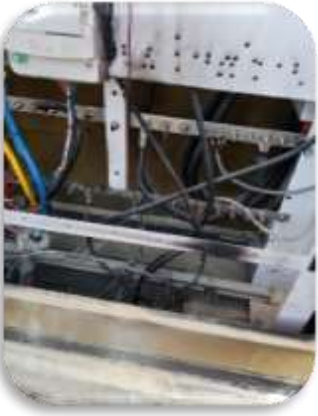
| <p><b>PELLSRUS- Seekoei Street (Shoprite Miniature substation)</b></p> <p>Burned LV cable due to floods excessive water buildup, cable had to be replaced.</p> | <p>Underground cable was upgraded from 70mmsq to 95mmsq cu cable.</p> | <p><b>R150 00.00</b></p> |

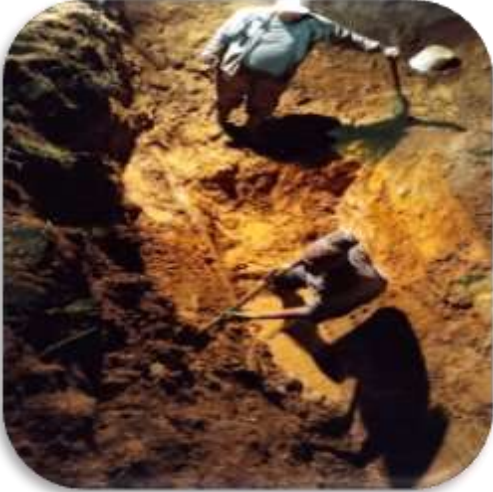
| <p><b>HUMANSDORP</b></p> <p><b>Park street underground 11kV cable</b></p> <p>MV cable in Park Street damaged.</p> | <ul style="list-style-type: none"> <li>Underground MV cable repaired</li> </ul> | <p><b>R130 000.00</b></p> |

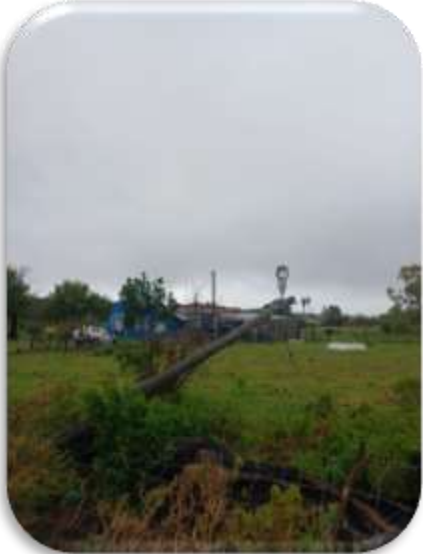
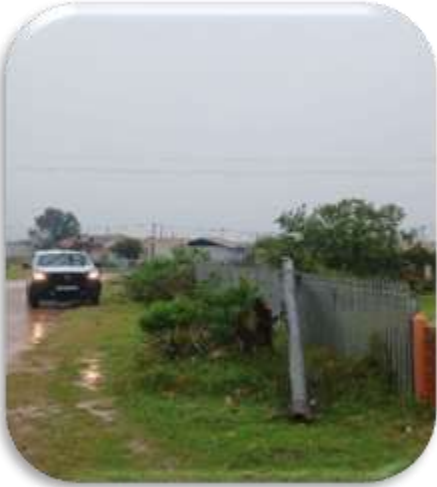
| <p>18 Poles for MV &amp; LV are temporary supported in ward 4,5, 6&amp; 15. Due waterlogged area and strong winds.</p> | <ul style="list-style-type: none"> <li>18 Poles for MV &amp; LV are temporary supported in ward 4,5, 6&amp;15</li> </ul> | <p><b>R 350 000</b></p> |

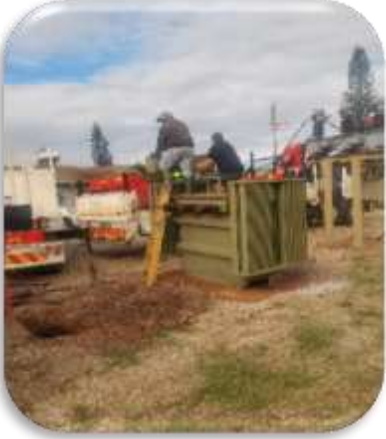
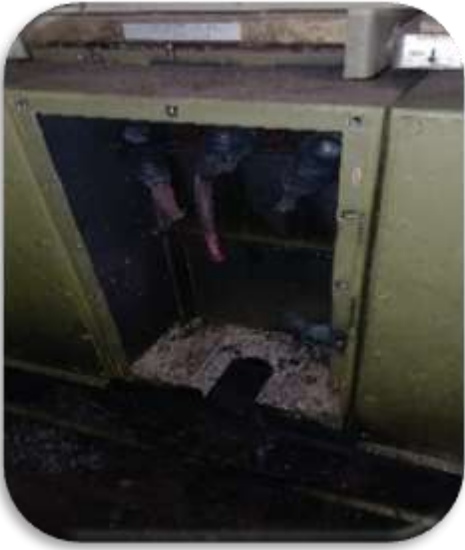
| <p><b>Met Melville substation:</b></p> <ul style="list-style-type: none"> <li>3150 kVA, 22/11 kV Transformer, underground cable, RMU and circuit breaker are damaged.</li> </ul> | <ul style="list-style-type: none"> <li>Circuit breaker and transformer to be replaced</li> </ul> | <p><b>R3 500 000.00</b></p> |
