# SPECIAL COUNCIL MEETING

DATE: 14 May 2026  
TIME: 10:00  
VENUE: Virtual

## **FLOOD DISASTER DAMAGE REPORT FROM 05 -11 MAY 2026**

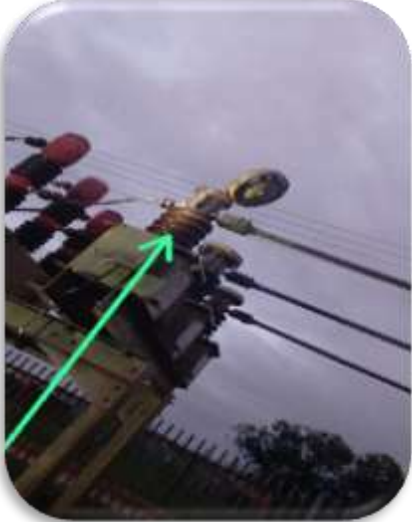
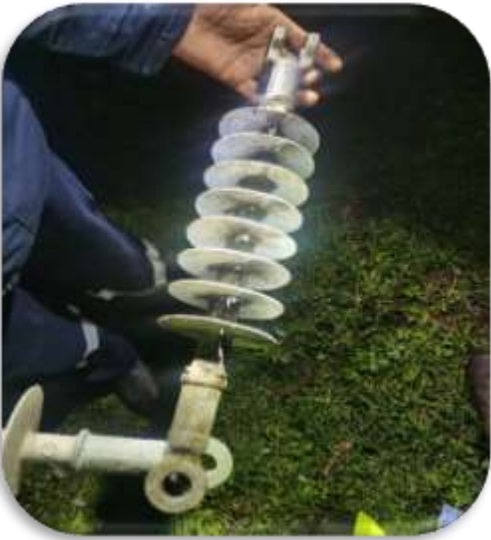
| <p><b>Common substation</b></p> <ul style="list-style-type: none"> <li>3150 kVA, 22/11 kV Transformer, CV, VT and circuit breaker are damaged.</li> </ul> <p>Overhead line faults in various areas in Humansdorp.</p> | <ul style="list-style-type: none"> <li>3150 kVA, 22/11 kV Transformer, CV, VT and circuit breaker to be replaced.</li> </ul> <p>Overhead line faults in various areas in Humansdorp to be replaced.</p> | <p><b>R4 500 000.00</b></p> <p><b>R500 000.00</b></p> |

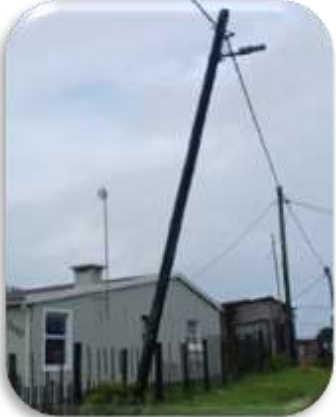
| <p><b>ST Francis Bay</b><br/><b>Sea Vista – Makriel Street</b></p> <ul style="list-style-type: none"> <li>The pole broke due to heavy winds</li> </ul> | <ul style="list-style-type: none"> <li>Installed a support pole</li> </ul> | <p><b>R 100 000.00</b></p> |

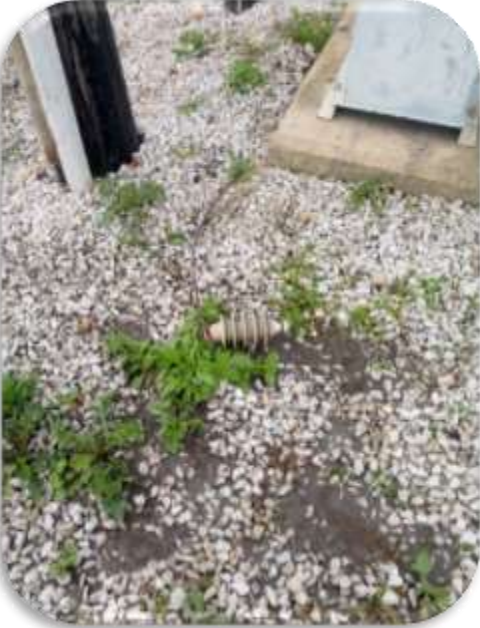
| <p><b>Load center 1 Main Substation – St Francis</b></p> <p>Cross-arm and all 11kV switchgear got damaged in the process.</p> | <p>Replaced the surge arrestor and the cut-out.</p> | <p><b>R 200 000.00</b></p> |

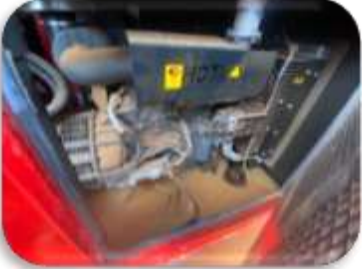
| <ul style="list-style-type: none"> <li>Phillipsville (old Hankey)</li> </ul> | <ul style="list-style-type: none"> <li>Himoinsa HSF –65-T5 60kVA Generator including electronics submerged in water. To be replaced.</li> </ul> | <b>R 300 000.00</b> |

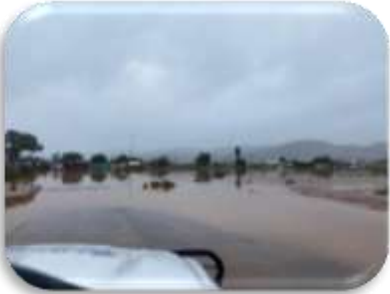
| <ul style="list-style-type: none"> <li>Stofwolk (Stormwater)</li> </ul> | <ul style="list-style-type: none"> <li>Due to excessive pumping, the 22kw Robot submersible pump overheated and must be replaced</li> <li>Mobile generator – submerged.</li> </ul> | <b>R 540 000.00</b> |

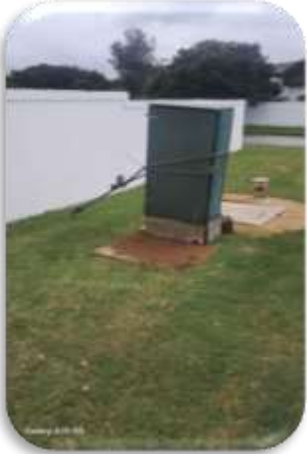
| <ul style="list-style-type: none"> <li>• <b>St Francis Bay</b></li> <li>• Seaglades Panel</li> </ul> | <ul style="list-style-type: none"> <li>• Panel cover to be replaced</li> </ul> | <p><b>R 25 000.00</b></p> |

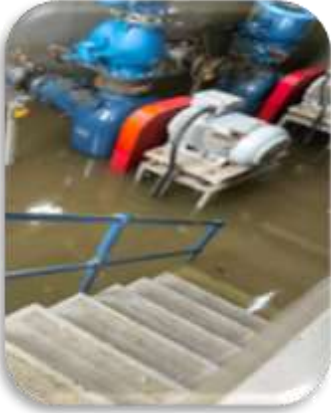
| <ul style="list-style-type: none"> <li>• <b>Jeffreys Bay</b></li> <li>• LaMer Pumpstation</li> </ul> | <ul style="list-style-type: none"> <li>• 0.37kw EVAK drainage pump</li> <li>• 2 x T10 Gorman Rupp Rotatings</li> <li>• 300kVA Generator</li> </ul> | <p><b>R 850 000.00</b></p> |

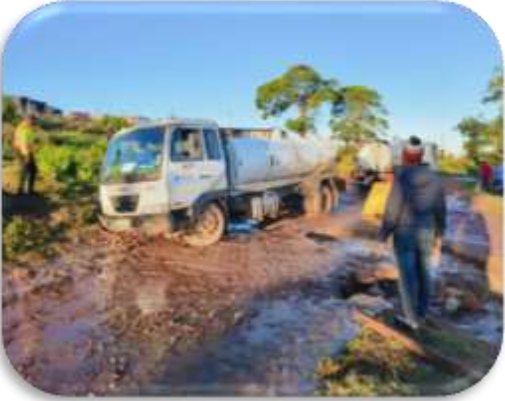
| Damage Reported in Affected Areas | Proposed Rehabilitation | Estimated Cost |
|---|---|---|
| <p><b>Humansdorp</b></p> <ul style="list-style-type: none"> <li>DXM 912 EC (Nissan UD 90 Suction Truck) - While assisting with the suction of storm and flood water, truck got stuck in the mud, and in the process damaged the rear bumper as it got pulled out.</li> </ul> | <ul style="list-style-type: none"> <li>To replace the entire rear bumper.</li> </ul> | <ul style="list-style-type: none"> <li><b>R8 000.00</b></li> </ul> |

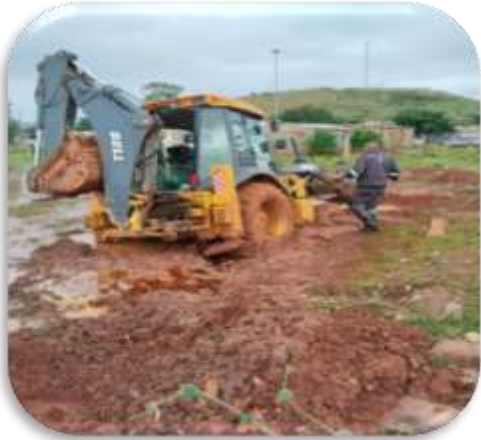
| Damage Reported in Affected Areas | Proposed Rehabilitation | Estimated Cost |
|---|---|---|
| <p><b>Hankey – Gamtoos Valley</b></p> <ul style="list-style-type: none"> <li>BELL TLB JLZ 151 EC sustained damages to it's hydraulic system as well as hydraulic pipes after it got stuck in the mud while attending to the flood disaster.</li> </ul> | <ul style="list-style-type: none"> <li>Replace all damaged hydraulic pipes and modify the damaged hydraulic system.</li> </ul> | <p><b>R12 000.00</b></p> |

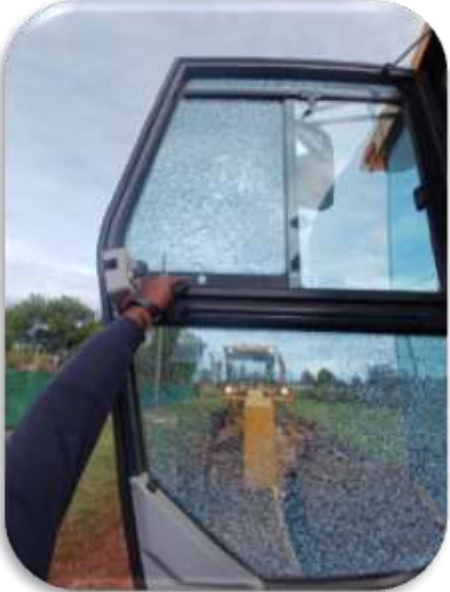
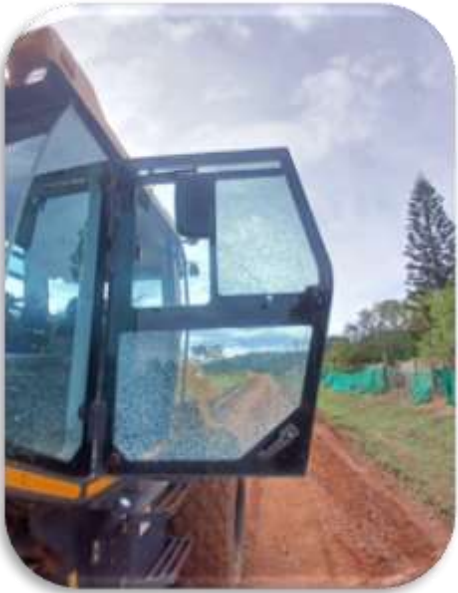
| <p><b>SHANTUI ROLLER - Humansdorp</b></p> <ul style="list-style-type: none"> <li>Left window suffered damages after a minor shot a rock with his slingshot and landed against the window of the roller while the roller was assisting with the flood disaster.</li> </ul> | <ul style="list-style-type: none"> <li>Replace left window of the roller.</li> </ul> | <p><b>R10 000.00</b></p> |

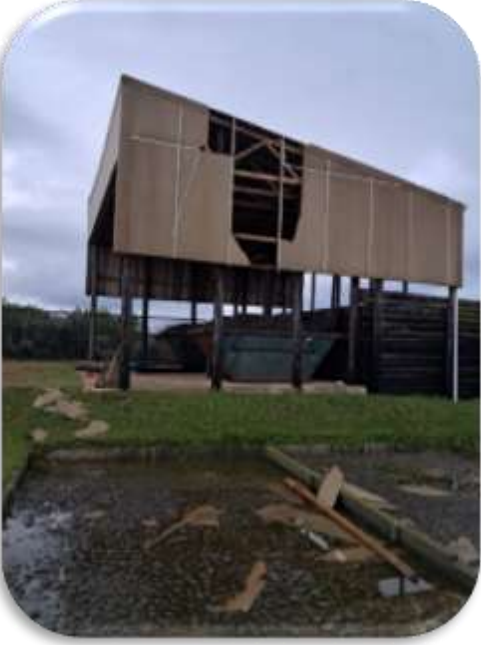
| Damage Reported in Affected Areas | Proposed Rehabilitation | Estimated Cost |
|---|---|---|
| <p>Saint Francis Bay Wastewater Treatment Works</p> <ul style="list-style-type: none"> <li>High winds ripped roof sheeting panels of the side of the building as shown in the picture below</li> </ul> | <ul style="list-style-type: none"> <li>Roof sheeting panels on the side of the building to be replaced.</li> </ul> | <ul style="list-style-type: none"> <li><b>R80 000.00</b></li> </ul> |

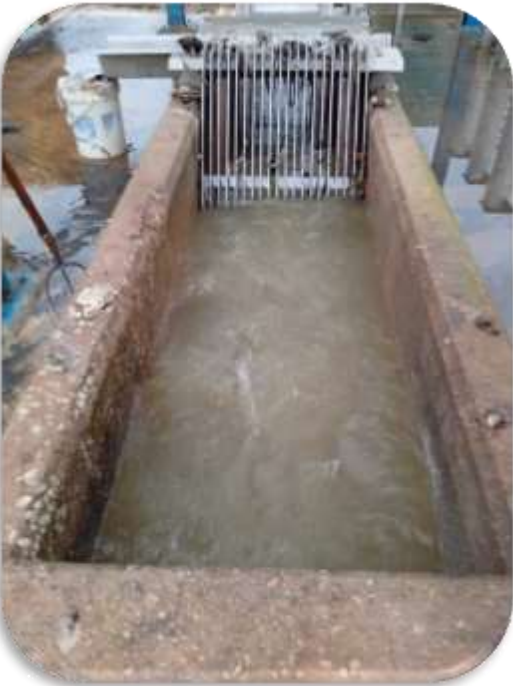
| Damage Reported in Affected Areas | Proposed Rehabilitation | Estimated Cost |
|---|---|---|
| <p>Kwanomzamo Wastewater Treatment Works</p> <ul style="list-style-type: none"> <li>Overwhelming inflow of foreign objects from sewer pump stations caused the static screen to become overwhelmed and objects ended up downstream of the screen. The damage these objects (like rocks) will do to the system is not yet known, as they can damage pumps and other mechanical equipment while moving through the system</li> </ul> | <ul style="list-style-type: none"> <li>Subsequent consequential damages are not yet known</li> </ul> | <ul style="list-style-type: none"> <li><b>Unknown</b></li> </ul> |

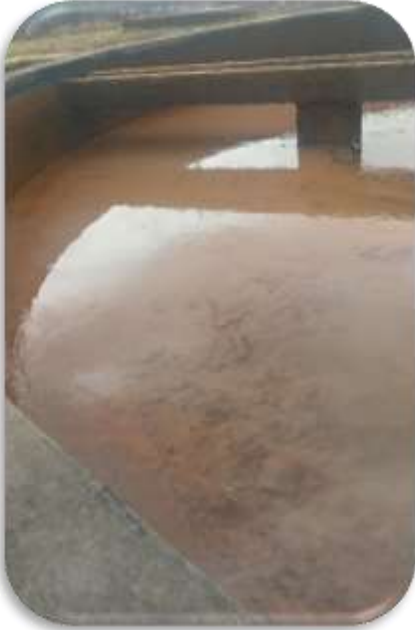
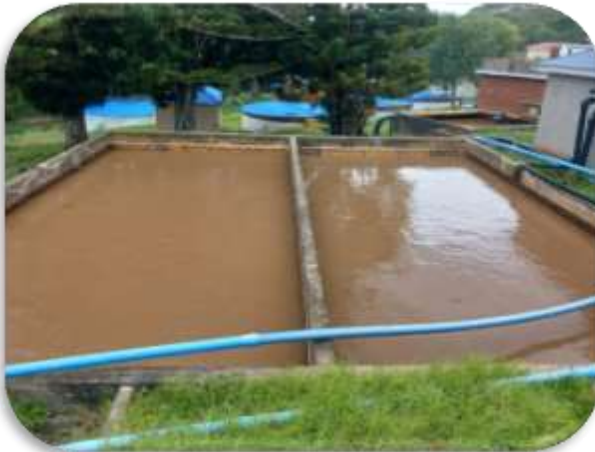
debris, the filter media inside the media filters was clogged up.

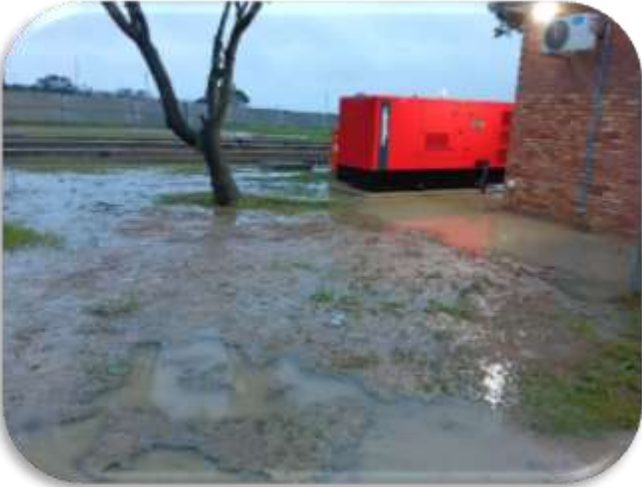
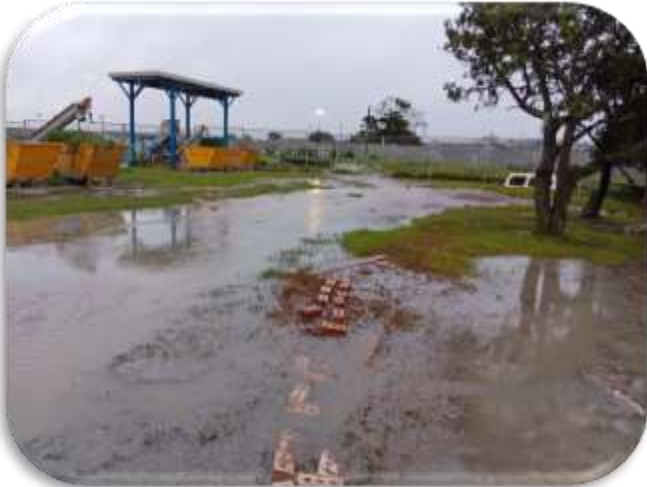
| Damage Reported in Affected Areas | Proposed Rehabilitation | Estimated Cost |
|---|---|---|
| <p>Kouga region: all Water and Wastewater Treatment Works</p> <ul style="list-style-type: none"> <li>During the flooding period it was observed that all 13 of the water and wastewater treatment facilities does not have dedicated drainage systems to prevent stormwater from ingress into the water and wastewater treatment works.</li> </ul> | <ul style="list-style-type: none"> <li>All water and wastewater treatment works should receive dedicated stormwater drainage systems to prevent stormwater from flowing into the treatment works.</li> </ul> | <ul style="list-style-type: none"> <li><b>Unknown</b></li> </ul> |
