# **GEOTECHNICAL ASSESSMENT REPORT**

**LOERIE SPORTS FIELD**

**BOSCH PROJECTS (PTY) LTD**

21 July 2022

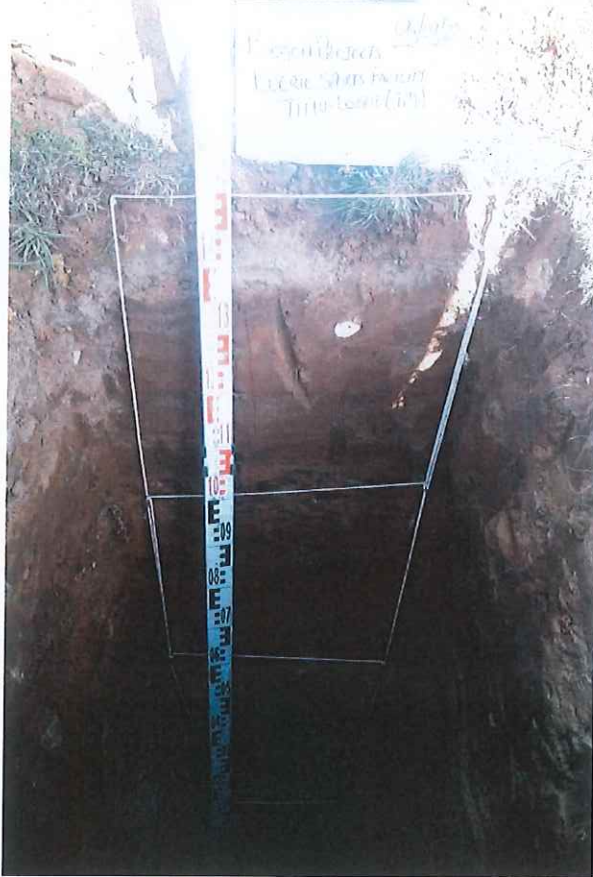
**Test Pit 1**

| Test Pit No. | Depth (mm) | Description | Indicator | | | | | In-Situ | | | Unified Soil Classification | TRH14 Classification | HRB Classification |
|---|---|---|---|---|---|---|---|---|---|---|---|---|---|
| TP 1 | 540-970 | Light Reddish Brown Clayey Sandy Silt | 88 | 82 | 38.8 | 0.91 | 16 | See Addendum D – DCP Reports | | | SC | G9 | A-6(2) |

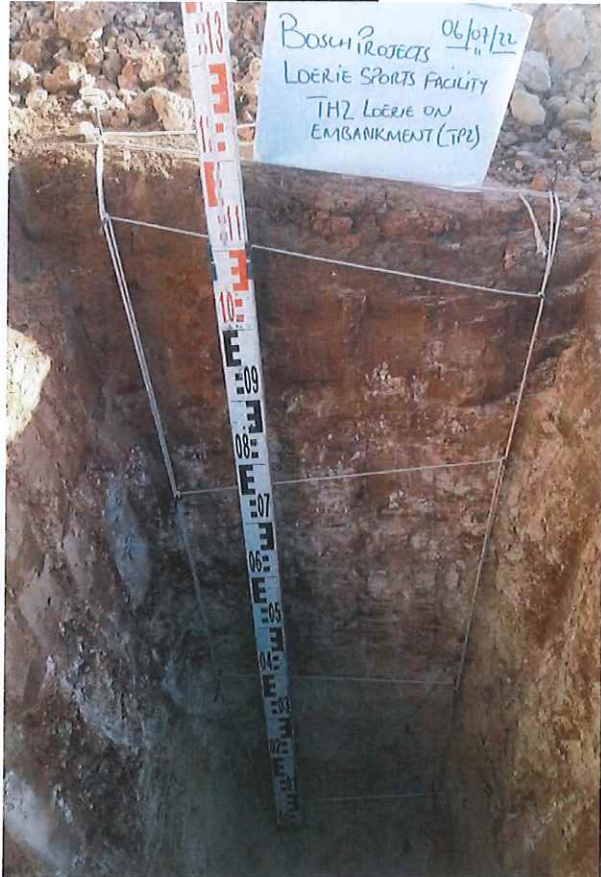
**Test Pit 2**

| Test Pit No. | Depth (mm) | Description | Indicator | | | | | In-Situ | | | Unified Soil Classification | TRH14 Classification | HRB Classification |
|---|---|---|---|---|---|---|---|---|---|---|---|---|---|
| TP 2 | 440-870 | Light Reddish Brownish Olive Clayey Silt with Sandstone Gravel | 66 | 63 | 48.2 | 1.23 | 7 | See Addendum D – DCP Reports | | | SC | <G9 | A-4(0) |

| INDICATOR / CBR RESULT SUMMARY | | | | | | |
|---|---|--|--|--|---|--|
| HRB CLASSIFICATION | - | | | | Slightly Moist, Light Brownish Redd,<br>Medium Dense, Intact, Sandy Silt with<br>Roots, Transported | |

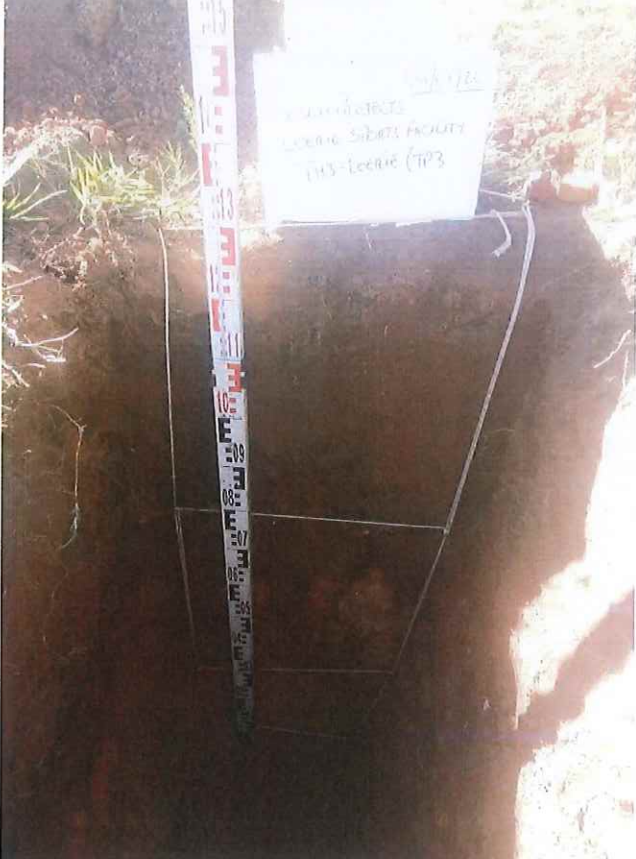
**Test Pit 3**

| Test Pit No. | Depth (mm) | Description | Indicator | | | | | In-Situ | | | Unified Soil Classification | TRH14 Classification | HRB Classification |
|---|---|---|---|---|---|---|---|---|---|---|---|---|---|
| TP 3 | 540-1030 | Light Yellowish Reddish Brown Clayey Gravelly Sandy Silt | 91 | 87 | 53.5 | 0.68 | 12 | See Addendum D – DCP Reports | | | CL | <G9 | A-6(3) |

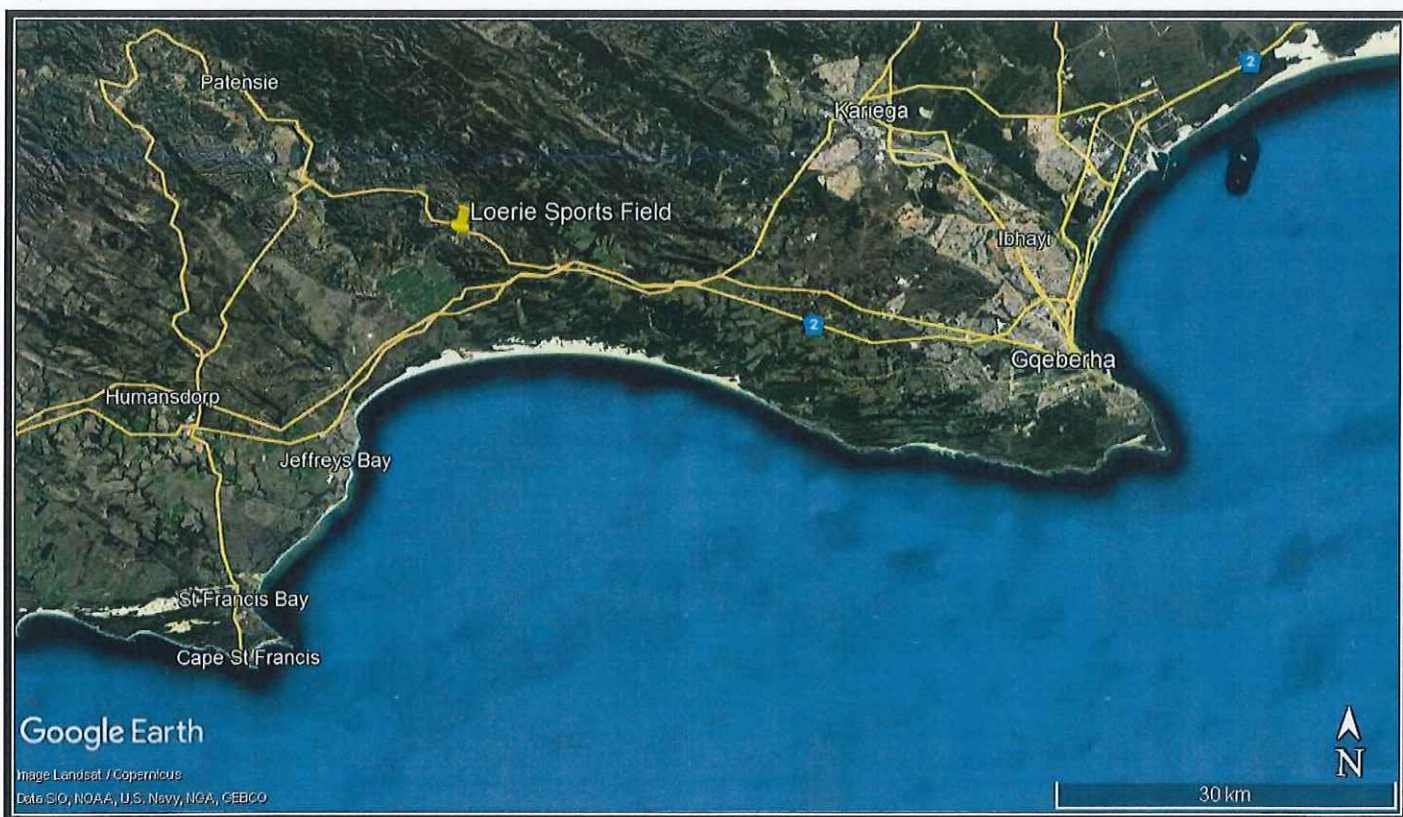
# AERIAL PHOTO

Three test pits locations were supplied by Bosch Projects (See Addendum B – Aerial Photo). The test pits were excavated by hand, with the intention to excavate all the test pits down to 1.5m depth, to determine the current subsurface conditions, however bedrock was encountered in test pits 2 and 3:

A locality plan is attached in Addendum B. The co-ordinates for the test pits and DCP's are noted on relevant result forms in Addendum D.
